Aslin Boat Surveys

REPORT OF SURVEY (CONDITION & VALUATION FOR INSURANCE)

At the request of _____ the undersigned did survey at the _____ Yacht Club, the steel 35 foot cruising sailboat " _____ " on April 12, 201_. The survey took place out of the water (mast down). The weather at the time of survey was overcast with a temperature of about 4c. The client was not in attendance.

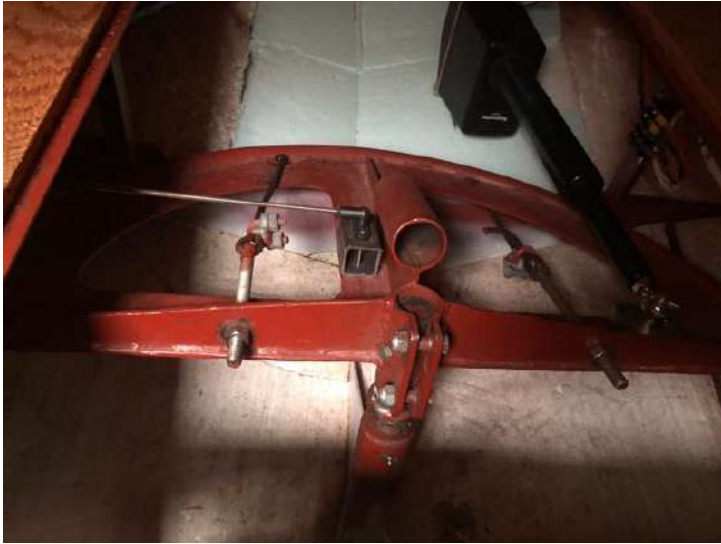
Quadrant.

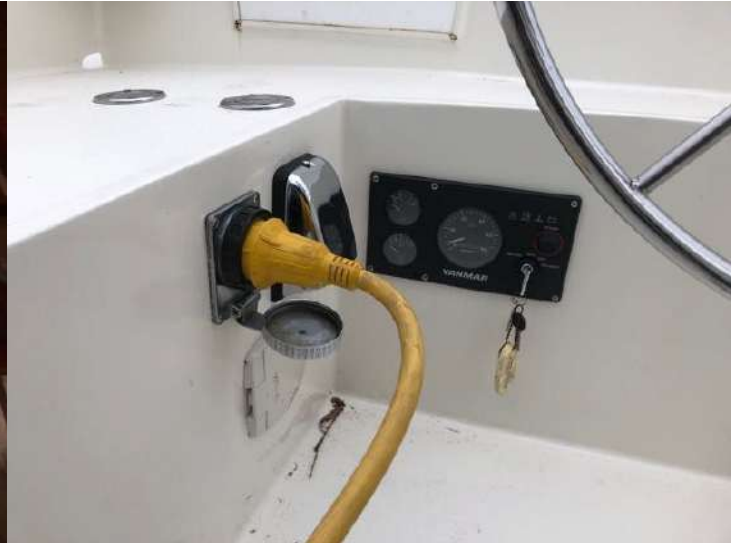
Vent, Pump, Engine Panel
